**Flood Control Project Maintenance  
Levee Inspections**

**Maintenance Issue Types Only, Levee Inspection Report By Mile - Fall 2016**

**Reclamation District No. 0787 Fair**

Waterway	Bank	Unit Miles	Inspection Start/End	Inspector
Unit No. 01 Colusa Basin Drain	Left	4.45	09/26/2016 09/26/2016	Oleg Yakimov

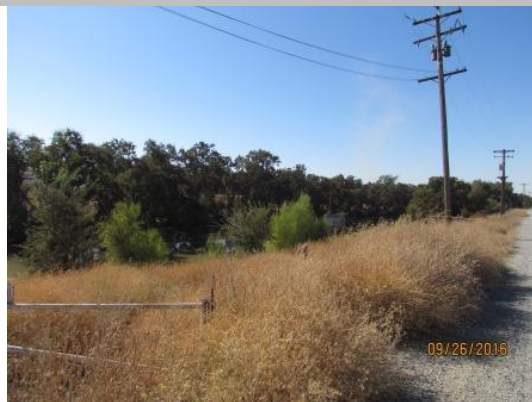
Photo 1 of 1 : FA\_2016\_RD0787\_212\_4\_20160926\_00013.jpg

LM Start	0.01	Rating **	M	Issue No.	4
LM End	0.02	Issue Type +	Ma	Location *	WS
Category	Earthen Levee			GPS Latitude/Longitude	
				Start	End
Item	Vegetation			38.799508 °	38.799464 °
				-121.725522 °	-121.725564 °
DWR ID	DWR_RD0787_01_f_2016_4				
Comment Code					
V2 : Remove the wild growth other than native grasses from the levee slopes.					
Inspector Comment

Vegetation on waterward slope. Fall 2016.

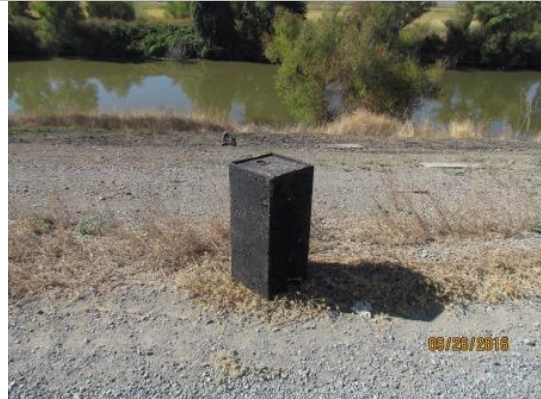
Photo 1 of 1 : FA\_2016\_RD0787\_212\_11\_20160926\_00012.jpg

LM Start	1.73	Rating **	M	Issue No.	11
LM End	1.73	Issue Type +	Ma	Location *	WS
Category	Earthen Levee			GPS Latitude/Longitude	
				Start	End
Item	Encroachments			38.802693°	38.802693°
				-121.752672°	-121.752672°
DWR ID	DWR_RD0787_01_f_2016_11				
Comment Code					
GA : Garbage					
Inspector Comment

Burnt loudspeaker near levee crown on waterward side. Fall 2016.
